**Flood Control Project Maintenance
Levee Inspections**
LMA District Cover Sheet
Spring 2010 Levee Inspection Results

Murphy Slough at M&T Ranch

Levee Inspection Report By Mile - Spring 2010

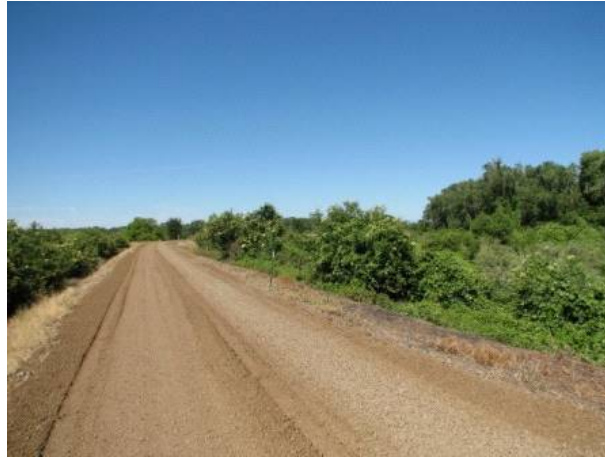
rduffey_s_20100622_069.jpg

Waterway						Bank	Unit Miles	Inspection Start/End	Inspector	
Unit No. 01 Murphy Slough at M&T Ranch						Left	0.78	05/07/2010 05/07/2010	Bob Duffey	
LMR No	Levee Mile		Category	Item	Location *	Rating **	Action/Comment	GPS Latitude/Longitude		Issue No. Photo
	Start	End						Start	End	
1	0.00	0.20	Earthen Levee	Vegetation	WS	M	Elderberries are blocking visibility and flood fight capability.	39.666988 ° -121.960993 °	39.666988 ° -121.960993 °	5 Y
2	0.00	0.30	Earthen Levee	Vegetation	LS	M	Elderberries are blocking visibility and flood fight capability.	39.667708 ° -121.959817 °	39.666983 ° -121.960997 °	4
3	0.00	0.78	Earthen Levee	Vegetation	LS	C	Remove the wild growth other than native grasses from the levee slopes.	39.667540 ° -121.959612 °	39.669763 ° -121.970150 °	1
4	0.00	0.78	Earthen Levee	Vegetation	WS	C	Remove the wild growth other than native grasses from the levee slopes.	39.667542 ° -121.959610 °	39.669765 ° -121.970148 °	2

Levee Mile Report Line	1
Start Levee Mile	0.00
End Levee Mile	0.20
Location	Water Side
Category	Earthen Levee
Item	Vegetation

View of the elderberries along the waterside slope of the levee.
